# Tudor Road

## INTERCHANGE

# AMATS: Technical Advisory Committee Meeting

May 7, 2026

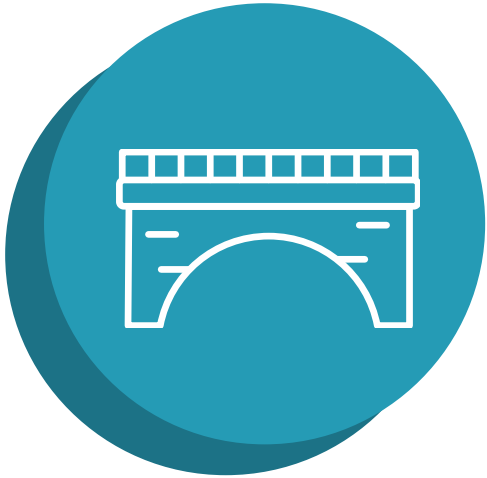
## Bridge

- Replace the aging bridge
- Increase vertical clearance to mitigate bridge strikes
- Widen to accommodate needs of all user groups

# Existing Interchange & Bridge Issues

- Existing bridge clearance is 2-ft below min. standards (strike hazard)
- Only 'medium' capacity (growth since '70s)
- Signalized intersections, 475' apart
- Typically 500'-700' signal spacing
- Difficult to coordinate signals
- Traffic platoons break down / spread out
- Queuing between ramp terminal intersections
- Acute ramp intersection angles degrade vehicular flow (large trucks)
- Sight distance (crest vertical curve, acute angles, no shoulders along bridge barriers)

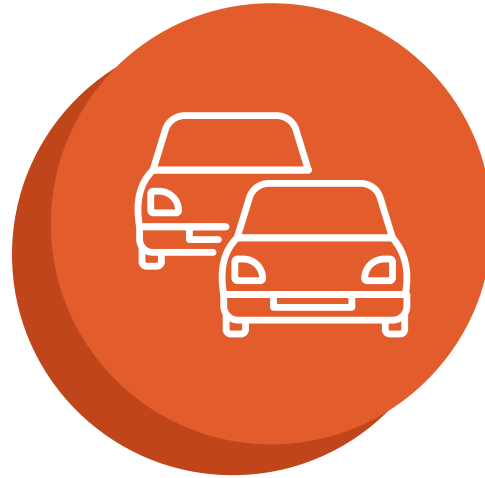
## Safety & Operations

- Improve traffic flow
- Reduce crash risk
- Reduce queuing

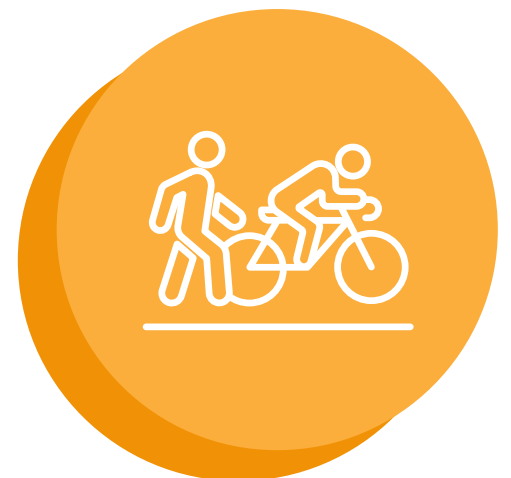
## Active Transportation

- Separate, widen, & enhance facilities
- Improve safety & connectivity

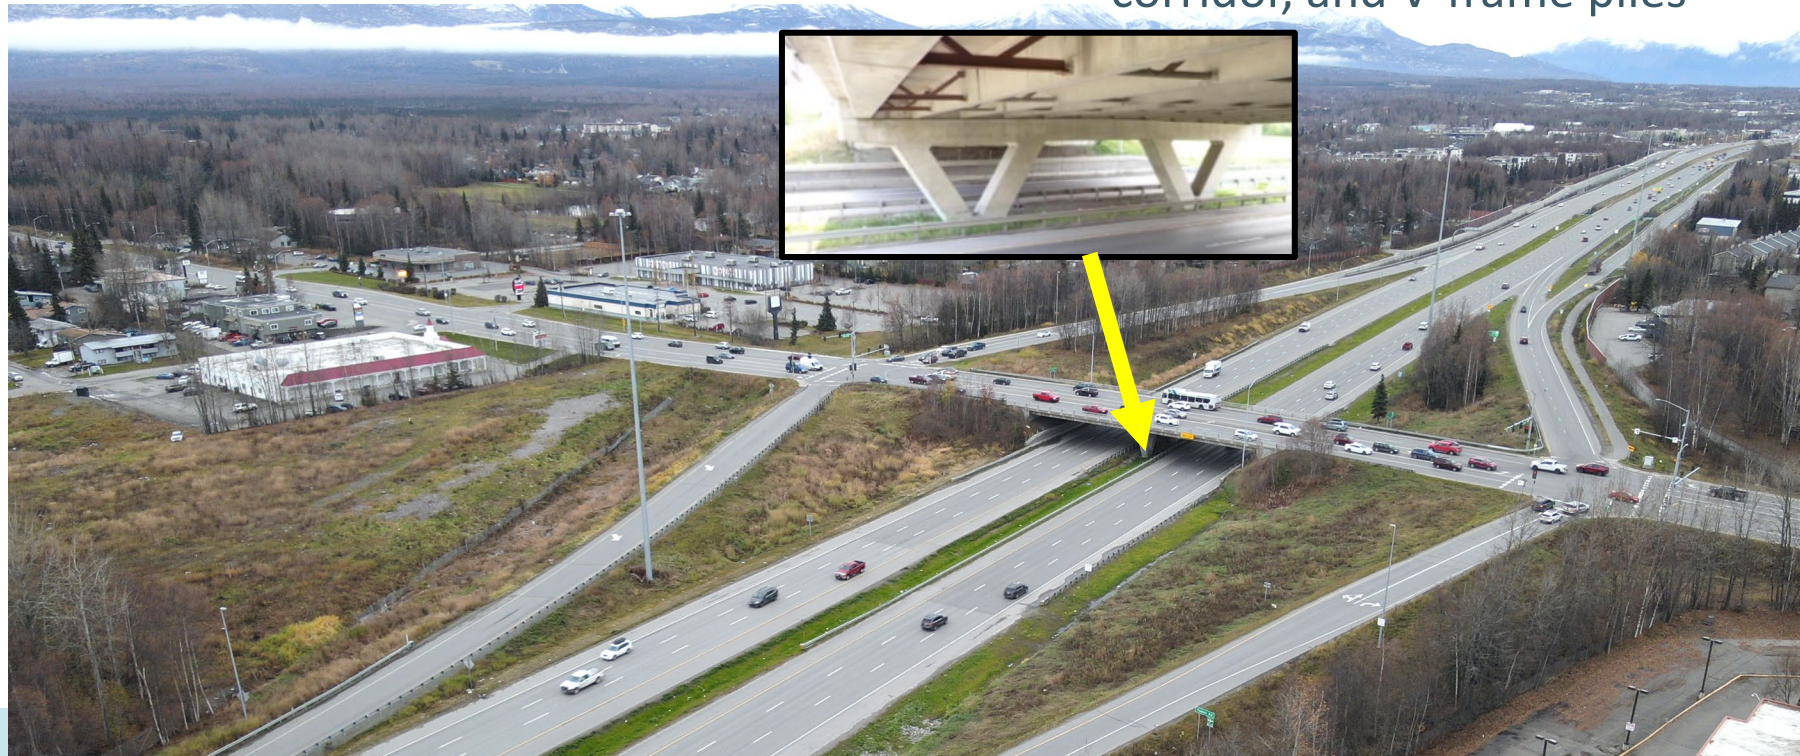
# Existing Interchange Conditions

- **Existing Traffic Volumes:**
  - Seward Hwy: 50,000 vehicles per day (vpd)
  - Tudor Rd: 36,500 vpd
- **Compressed Diamond Interchange** (suburban 1950s/60s design)
- **Non-motorized facilities:**
  - Narrow 4-ft sidewalks
  - Minimal/no separation from traffic
  - Lacking crossing at MacInnes St
- **Aging Bridge:**
  - Built 1976 (~50 years old)
  - Increased seismic vulnerability due to heavy traffic, critical corridor, and V-frame piles

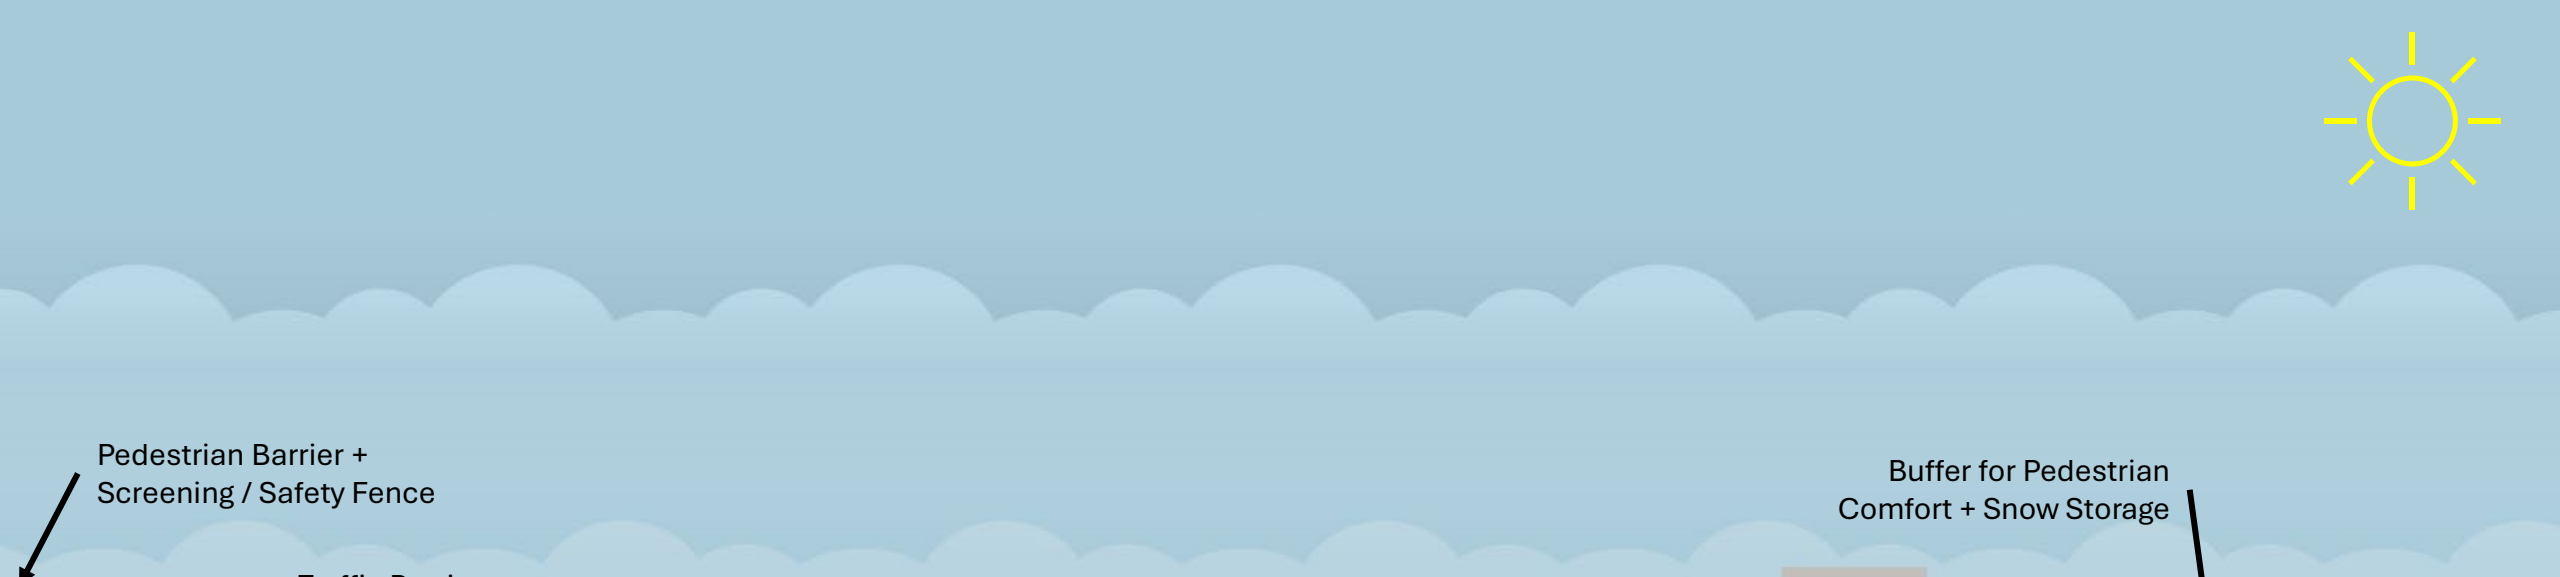
- **Sight Distance**
  - Flattening crest vertical curves = improved ability to see crossing users
  - Wide shoulders on bridge = barriers don't block intersection sight distance
- **Non-Motorized**
  - Converting sidewalks to widened shared-use pathways
  - Safety buffers, pedestrian barriers & refuges on Tudor Rd
  - Signalized crossing at MacInnes Dr
  - Investigating wide pedestrian undercrossing on west side (under Tudor Rd)
- **Operational**
  - Mitigate turn-lane queues from blocking intersections and ramp traffic
  - Squaring up ramp angles = less queuing on bridge
  - Tighter signal spacing = improved signal progression
- **Maintenance**
  - Improved snow storage
  - New storm drain + storm water retention basins
